**KEEYASK GENERATION
PROJECT**

**PHYSICAL ENVIRONMENT
SUPPORTING VOLUME**

DEBRIS

June 2012

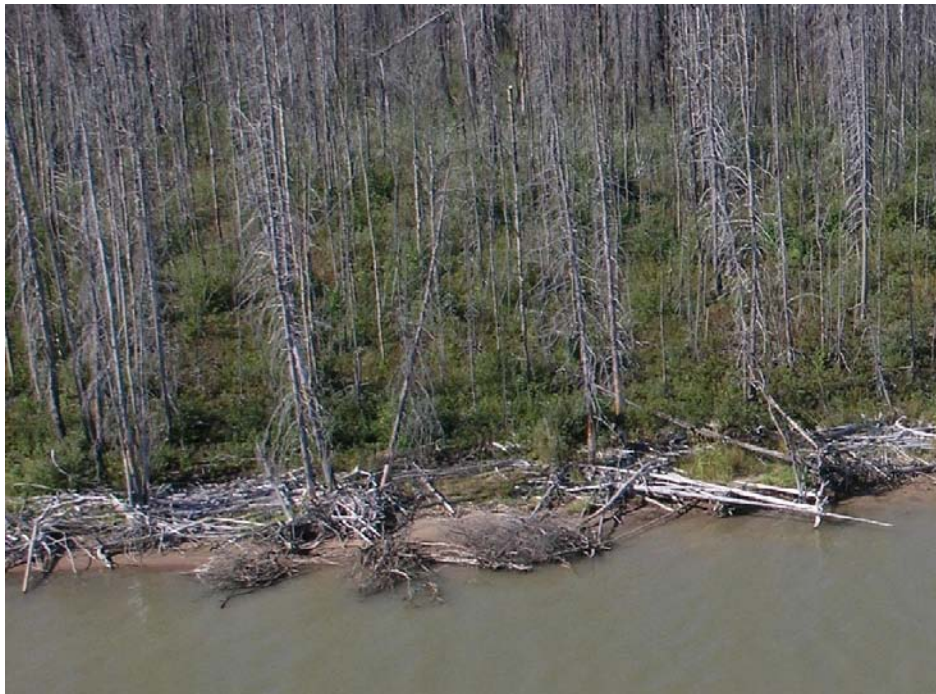
Photo 10.2-1: Example of Densely Distributed Beached Woody Debris Found on the South Shore of Gull Lake

1. Beached Woody Debris: debris that is found at or above the average water level along the shore (Photo 10.2-1 and Photo 10.2-2).
2. Standing Dead Trees: flooded trees that are still standing but no longer alive (Photo 10.2-5).

- Density = 1: low density and sparsely distributed (Photo 10.2-2).
- Density = 2: medium density distribution (Photo 10.2-3).
- Density = 3: densely distributed debris (Photo 10.2-1).

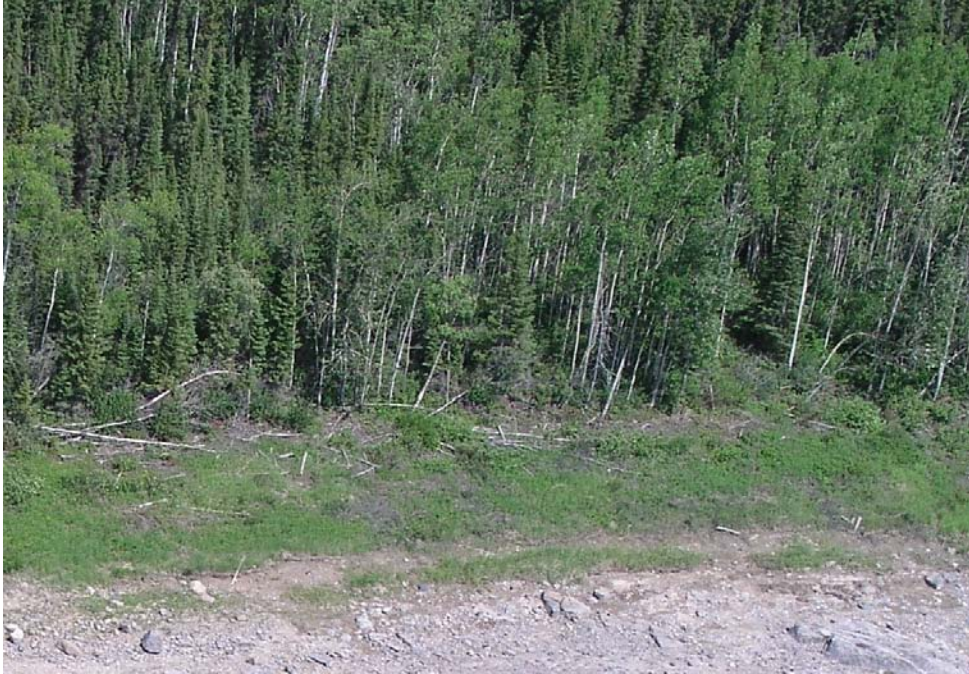
Photo 10.2-2: Beached Debris that is of Light Density and Sparsely Distributed

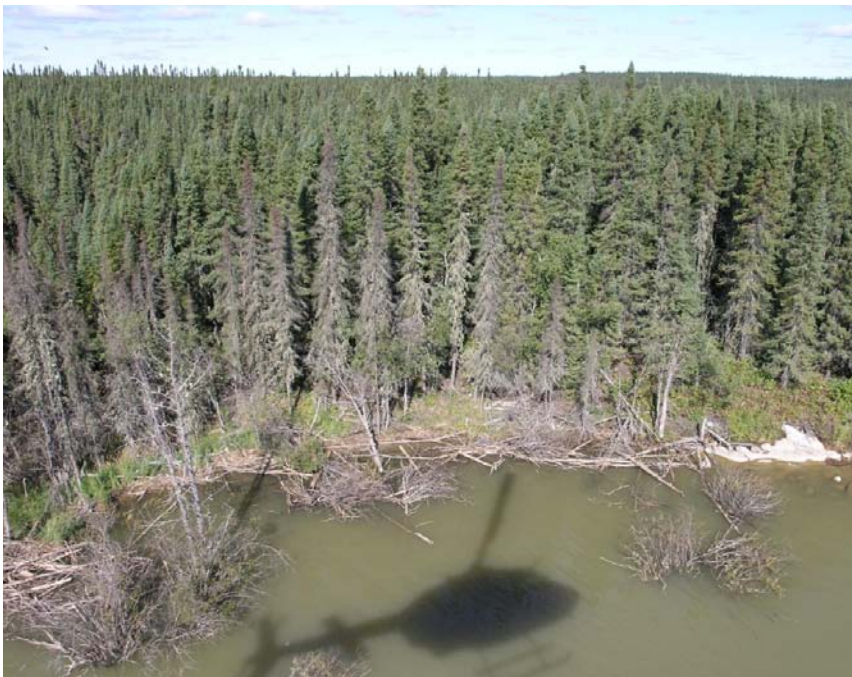
Photo 10.2-3: Medium Density Floating as well as Light Submerged Debris can be seen here on the North Shore of Gull Lake

debris floats loosely near the shore (Photo 10.2-3), but is not entangled amongst other debris, as with rafted debris.

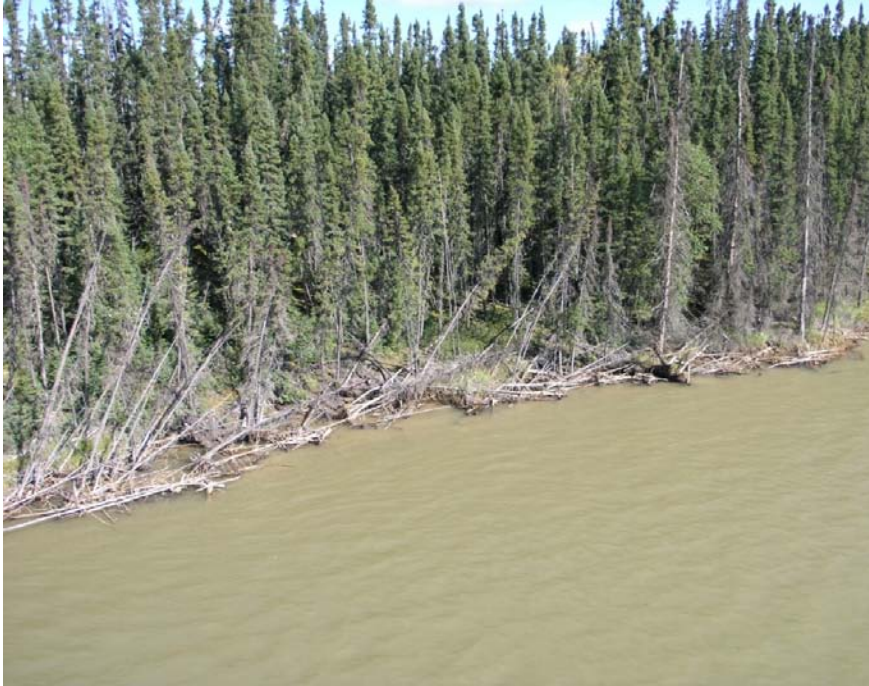
Photo 10.2-4: Leaning Trees of Medium Density on the North Shore of Gull Lake

5. Leaning Trees: trees along the shoreline that are tipping towards the water due to shoreline erosion of their root structure. In most cases, leaning trees will eventually enter the water after the shoreline upon which they are rooted has eroded (Photo 10.2-4).
6. Submerged Debris: trees or brush that are in the water but are not mobile (Photo 10.2-3). Typically, submerged logs are those below the surface and can occasionally be seen in areas of clear shallow water or when there is a high water level condition.
7. Deadheads: trees which are in the waterway but not mobile. Deadheads have one end floating just at the surface while the other end is either on the bottom **substrate** or embedded into it.

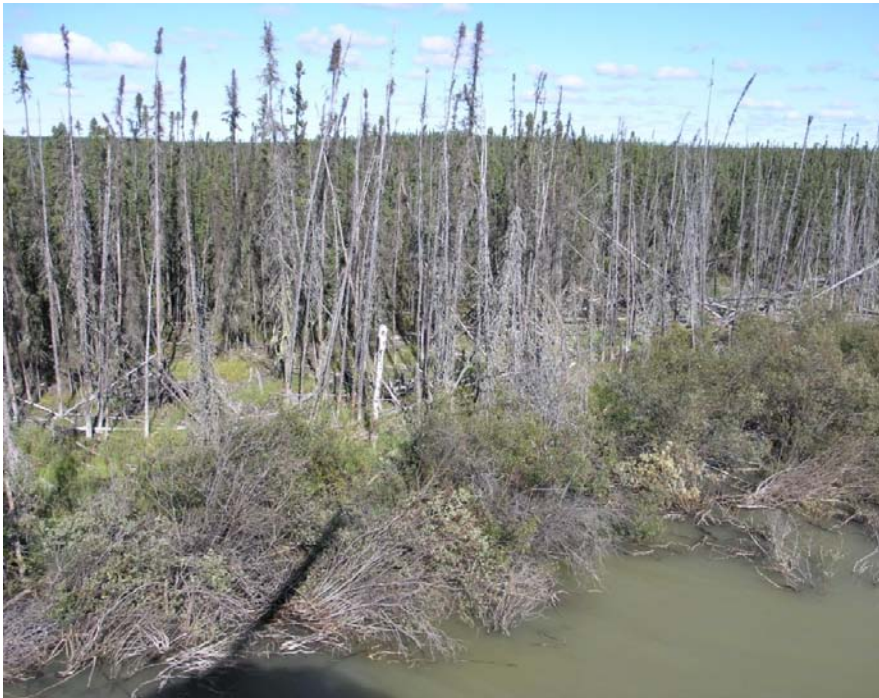
Photo 10.2-5: Medium Density Standing Dead Trees in an Inlet on the North Side of the Nelson River

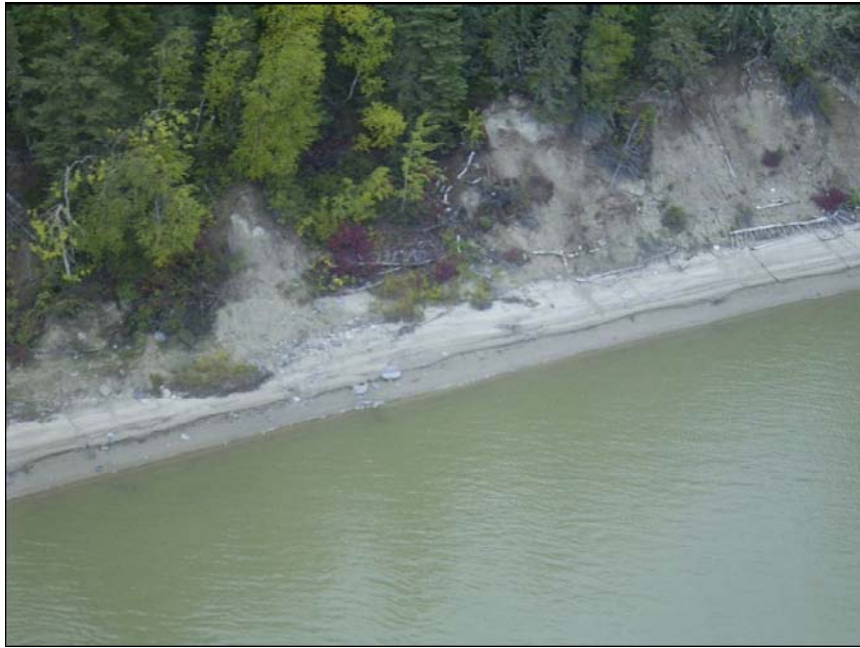
**Photo 10.3-1 Eroding Mineral Soil Bank Between Clark Lake and Birthday Rapids.
Photo Taken 19 September 2007**

Mineral erosion creates eroded beach slopes and adjacent, steeply sloping banks in **shore zone** areas. Vegetation growing on **upland** areas adjacent to eroding banks may fall onto the shoreline resulting in debris that may mobilize and move into the waterbody (Photo 10.3-1 and Photo 10.3-2). Localized slope failures also generate debris that enters the river (Photo 10.3-3).

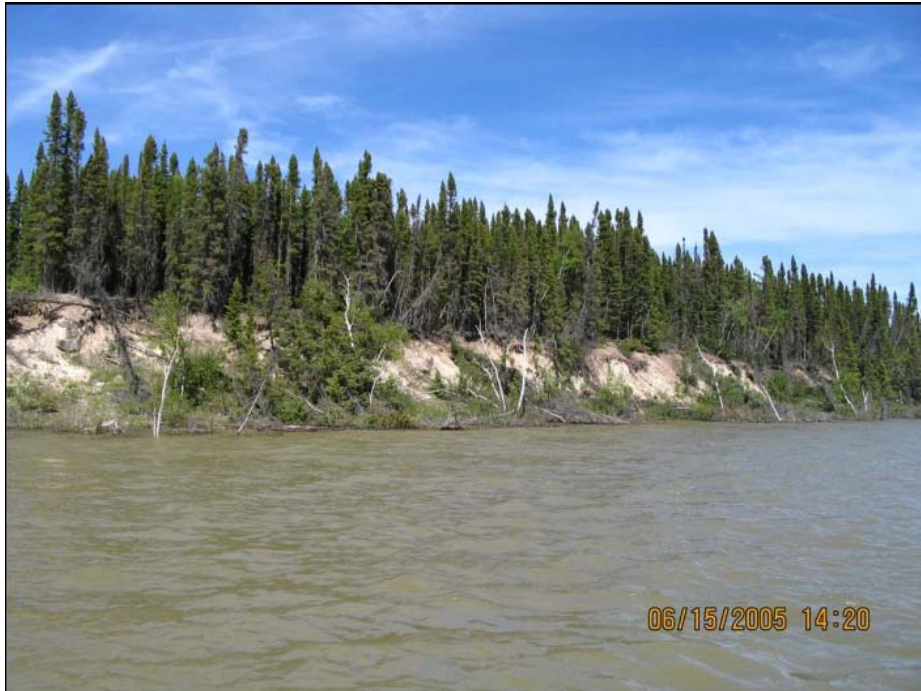
Photo 10.3-2: High Banks, South Side of Caribou Island, in Gull Lake Upstream from Gull Rapids

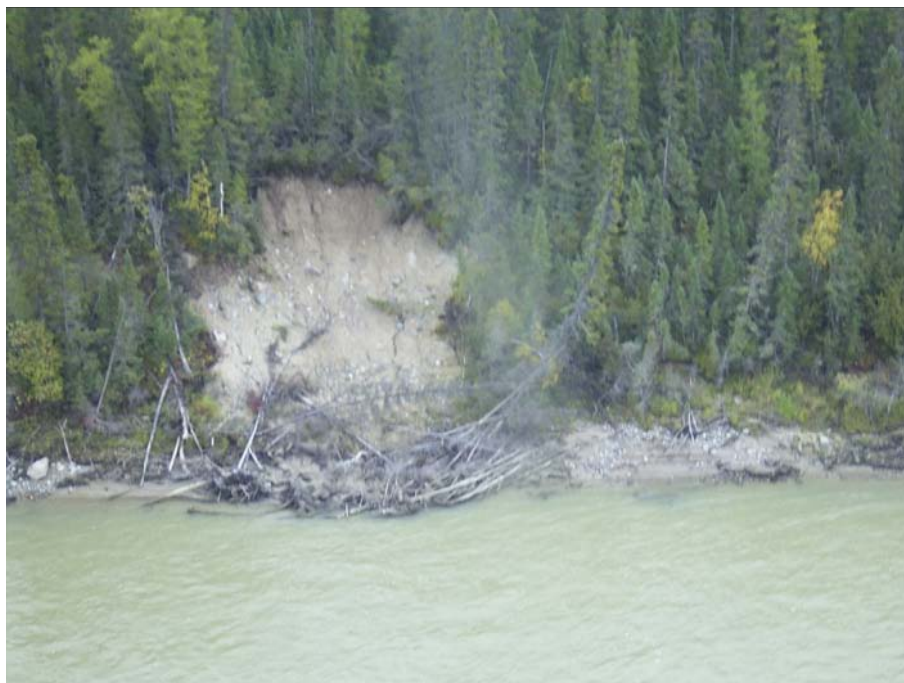
Photo 10.3-3: Localized Slope Failure in Mineral Soil Bank Between Clark Lake and Birthday Rapids. Photo Taken 19 September 2007

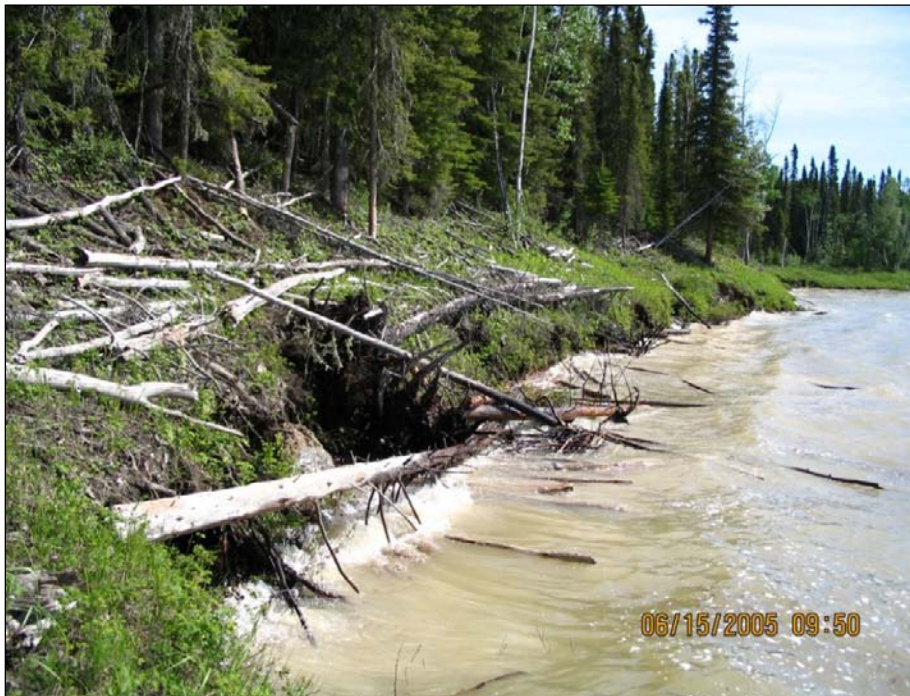
Photo 10.3-4: Example of Low Eroding Mineral Soil Bank and Ice-Scour Zone Below Trees in River Reach Between Birthday Rapids and Gull Lake

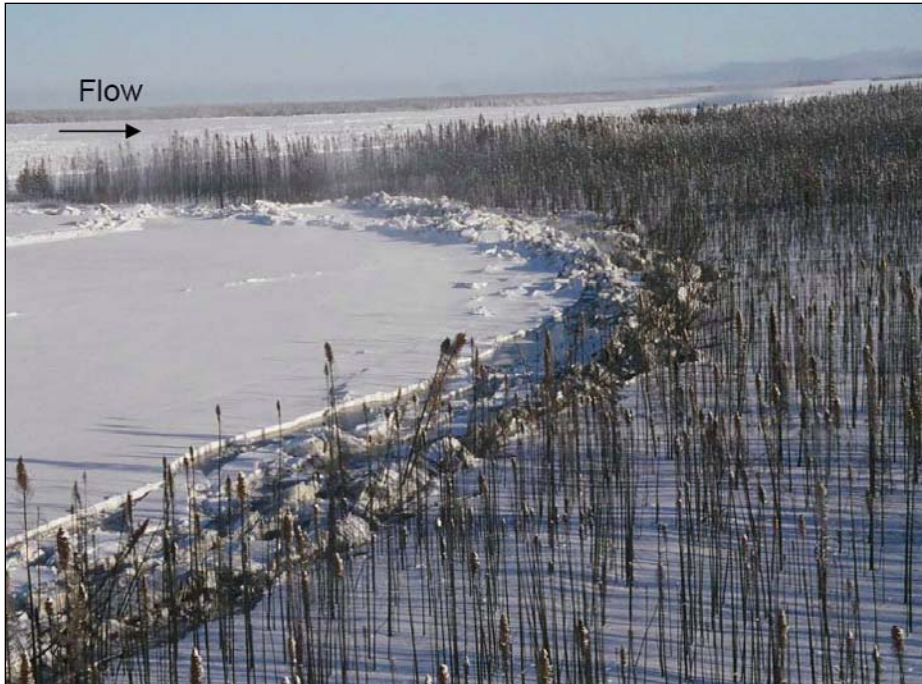
Photo 10.3-5: Example of River Ice Bull Dozing Trees Along Shoreline

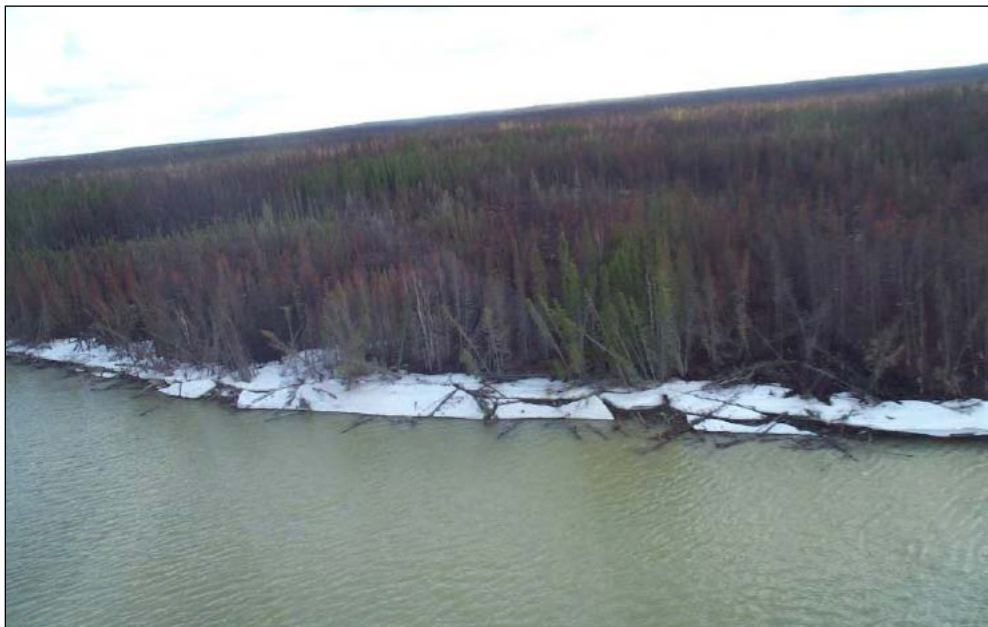
Photo 10.3-6: Example of Border Ice Collapsing Onto Shore Zone Where Woody Debris is Pulled into the River by the Ice

open water elevation. In some locations, ice has shoved coarse **gravel, cobbles** and **boulders** onto the shore, effectively protecting these shorelines from erosion. In other places, the ice shoving pushes over trees and other vegetation (Photo 10.3-4 and Photo 10.3-5). There are certain areas of Gull Lake where the shores may be protected by **border ice** that remains attached to the shore, thereby acting as a **buffer** to ice shoving. Border ice, however, may create new debris if it causes woody or peat material to be pulled away from the shore when the ice recedes in spring (Photo 10.3-6).
